CONWAY LAKE DAM

NH 00318

PHASE I INSPECTION REPORT NATIONAL DAM INSPECTION PROGRAM

NOVEMBER 1978

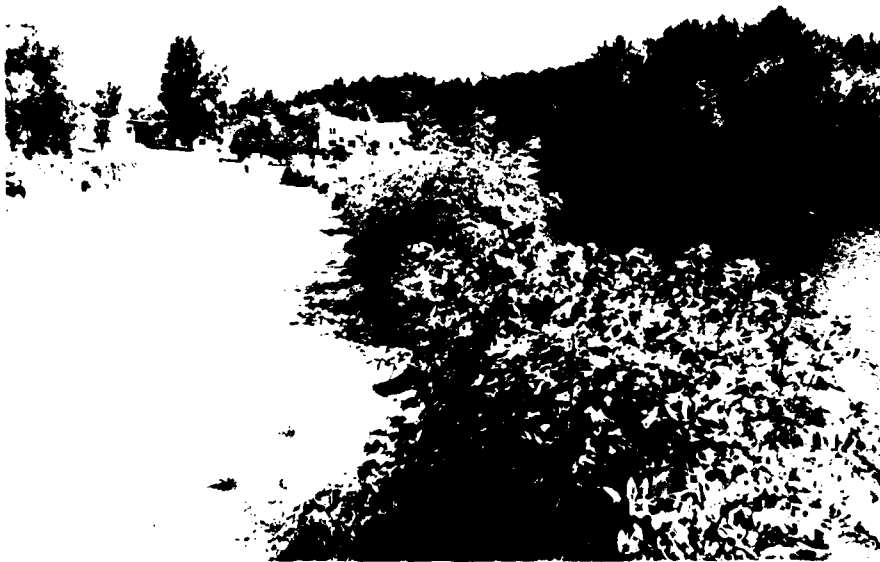
PHOTO NO. 3 - General view of dam from left abutment
(Upstream Side).

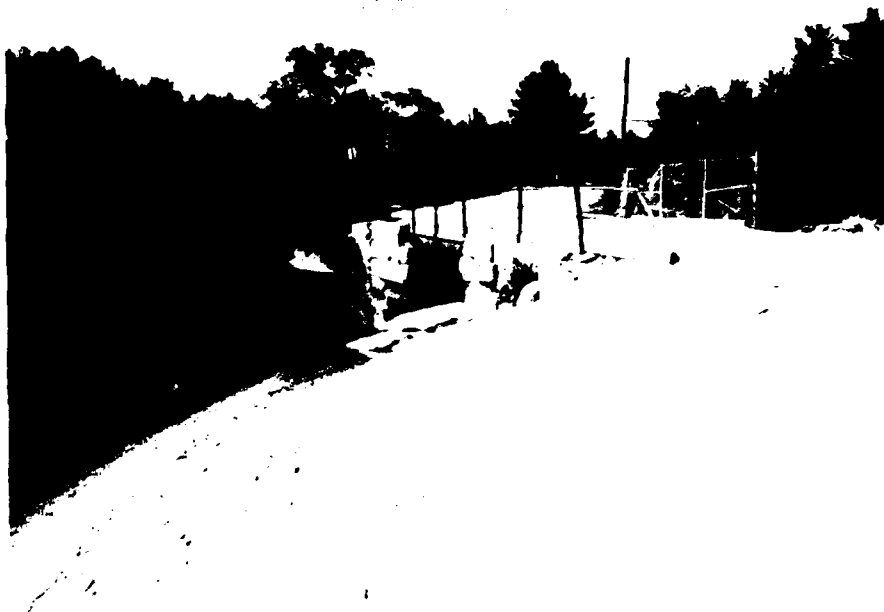
PHOTO NO. 4 - View of dam and roadway bridge from
right abutment (Upstream Slope).
